**THIRTEENTH MEETING OF THE UJNR
PANEL ON FIRE RESEARCH AND SAFETY,
MARCH 13-20, 1996**

THE PERFORMANCE OF FIRE PROTECTION OF BUILDINGS AGAINST THE FIRES FOLLOWING THE GREAT HANSHIN-AWAJI EARTHQUAKE

Akihiko Hokugo

Building Research Institute
Ministry of Construction
1 Tatehara, Tsukuba, 305, Japan

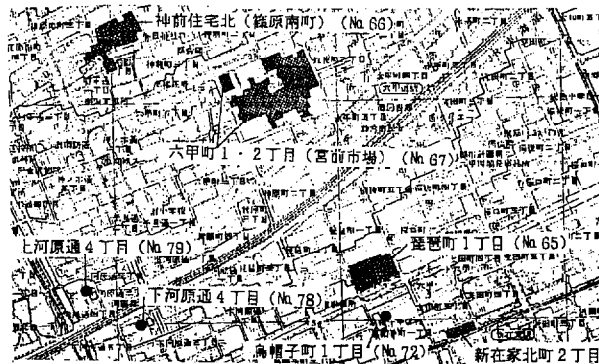
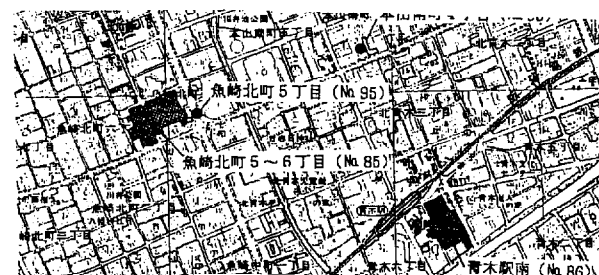
Figure 2. Large Conflagrations in Kobe City

Of 150 fire sites investigated by BRI, 73 fires involved single building and 77 involved multiple buildings. The number of fire sites less than 1,000 square meters is 33. Seven fires spread over 33,000 square meters. Other 37 fire sites are between 1,000 and 33,000 square meters. Figure 2 shows large conflagrations whose area is over 3,300 square meters in Nagata, Suma, Hyogo, Nada and Higashi-Nada Ward.
